Intel[®] 80219 General Purpose PCI Processor

Specification Update

July 2004

Document Number: [274020-002](#)

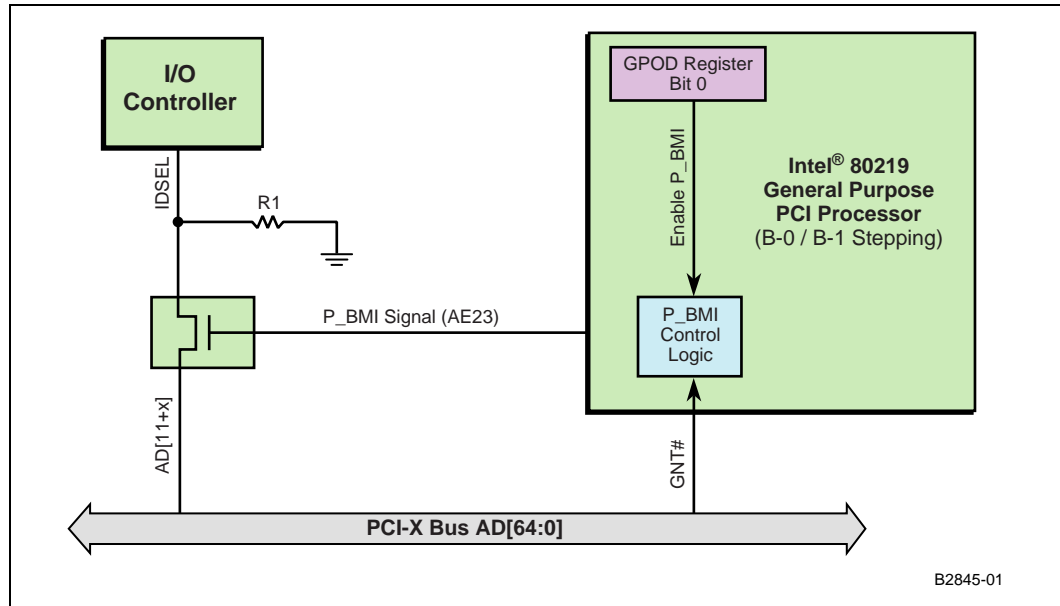
Figure 2. Intel® 80219 General Purpose PCI Processor P_BMI Signal Implementation for Intel® 80219 General Purpose PCI Processor B-0/B-1 Stepping

The P_BMI (AE23) signal has been added to the Intel® 80219 general purpose PCI processor. This signal replaces, using an external GPIO pin for Initialization Device Select (IDSEL) control of an I/O device during host configuration cycles.

Note: The host BIOS does not require any modifications to accommodate this implementation. All the responsibility for I/O device configuration and resource falls to the 80219 firmware.
